# **Appendix A:**

## **Point Intercept Plant Survey Data (2019)**

**Crescent Lake**  
**Aquatic Invasive Species Prevention  
& Planning Project**

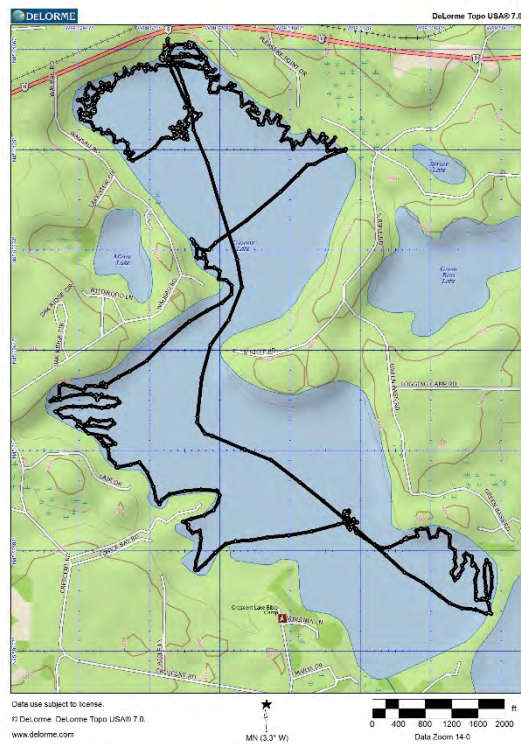
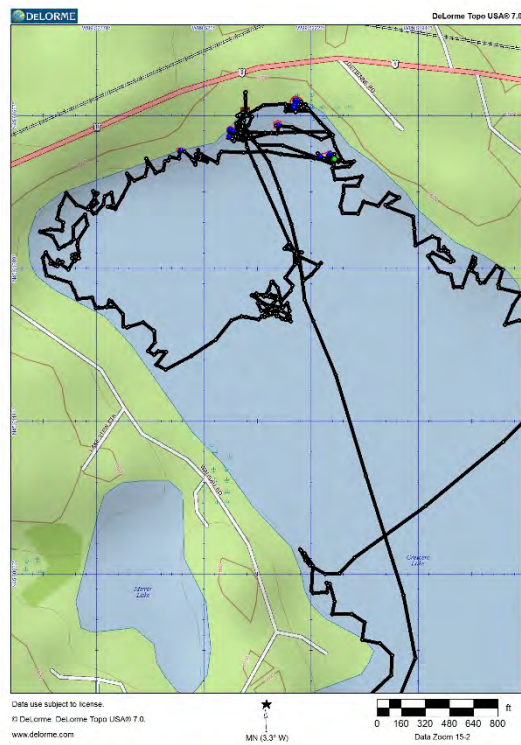
Figure 1. Crescent Lake Eurasian watermilfoil survey and delineation GPS track (5 May 2017)

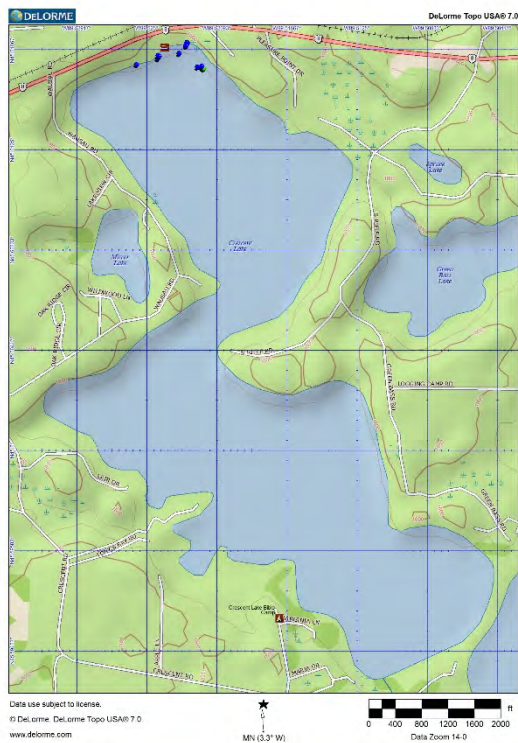
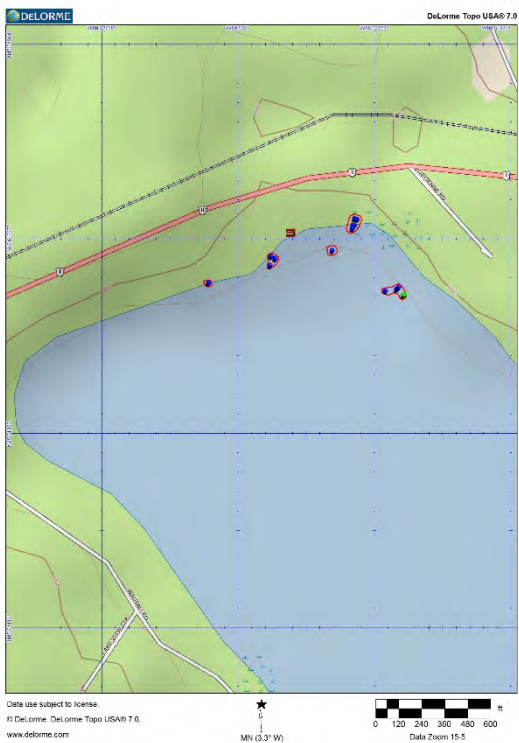
Figure 2. Crescent Lake Eurasian watermilfoil distribution and densities

- 0 – no milfoil plants were observed (no dot on map. Figure 2)
- 1 – 1 milfoil plant was observed (blue dot on map)
- 2 – scattered individual plants (green dot on map)
- 3 – scattered small clumps or clusters of milfoil plants (yellow dot on map)
- 4 – dense but scattered clumps or clusters of milfoil plants (orange dot on map)
- 5 – dense beds of milfoil plants (red dot on map)

A low number of individual milfoil plants were located on the north end of the lake (Figure 2). Only two sites had a density rating of 2 and no sites with ratings greater than 2 were observed. Milfoil currently represents a minor part of the overall aquatic plant community.

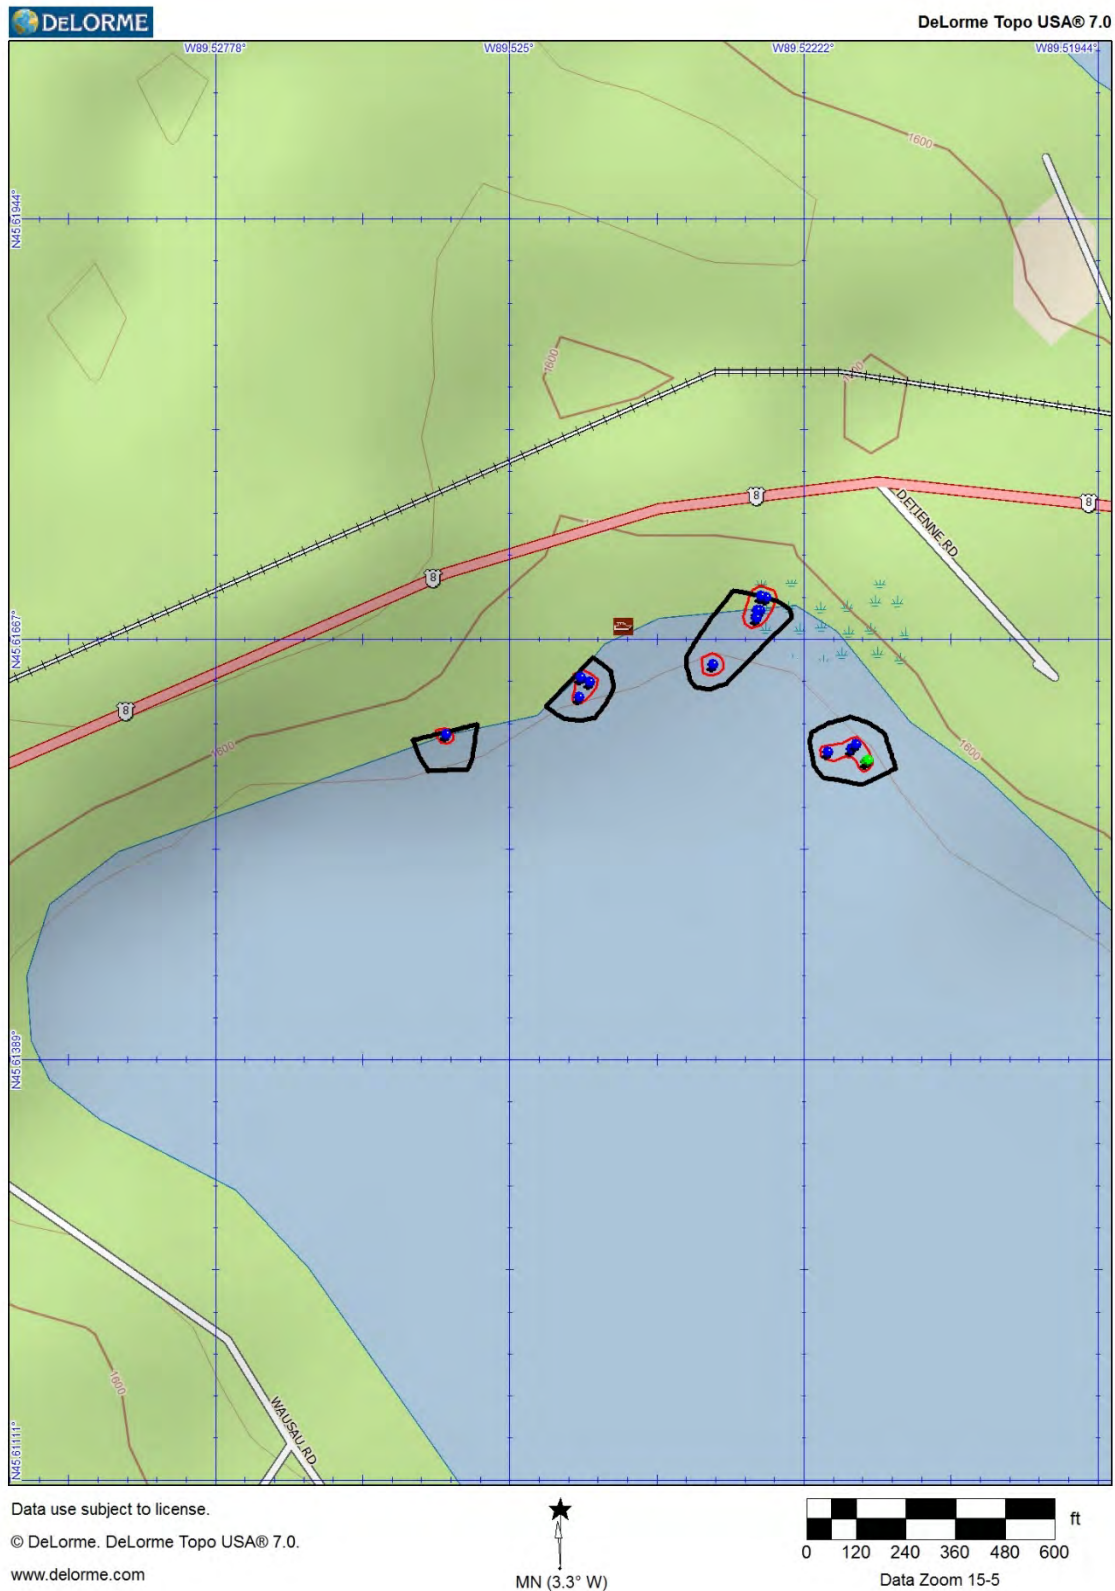
Figure 3. Crescent Lake Small herbicide treatment polygons

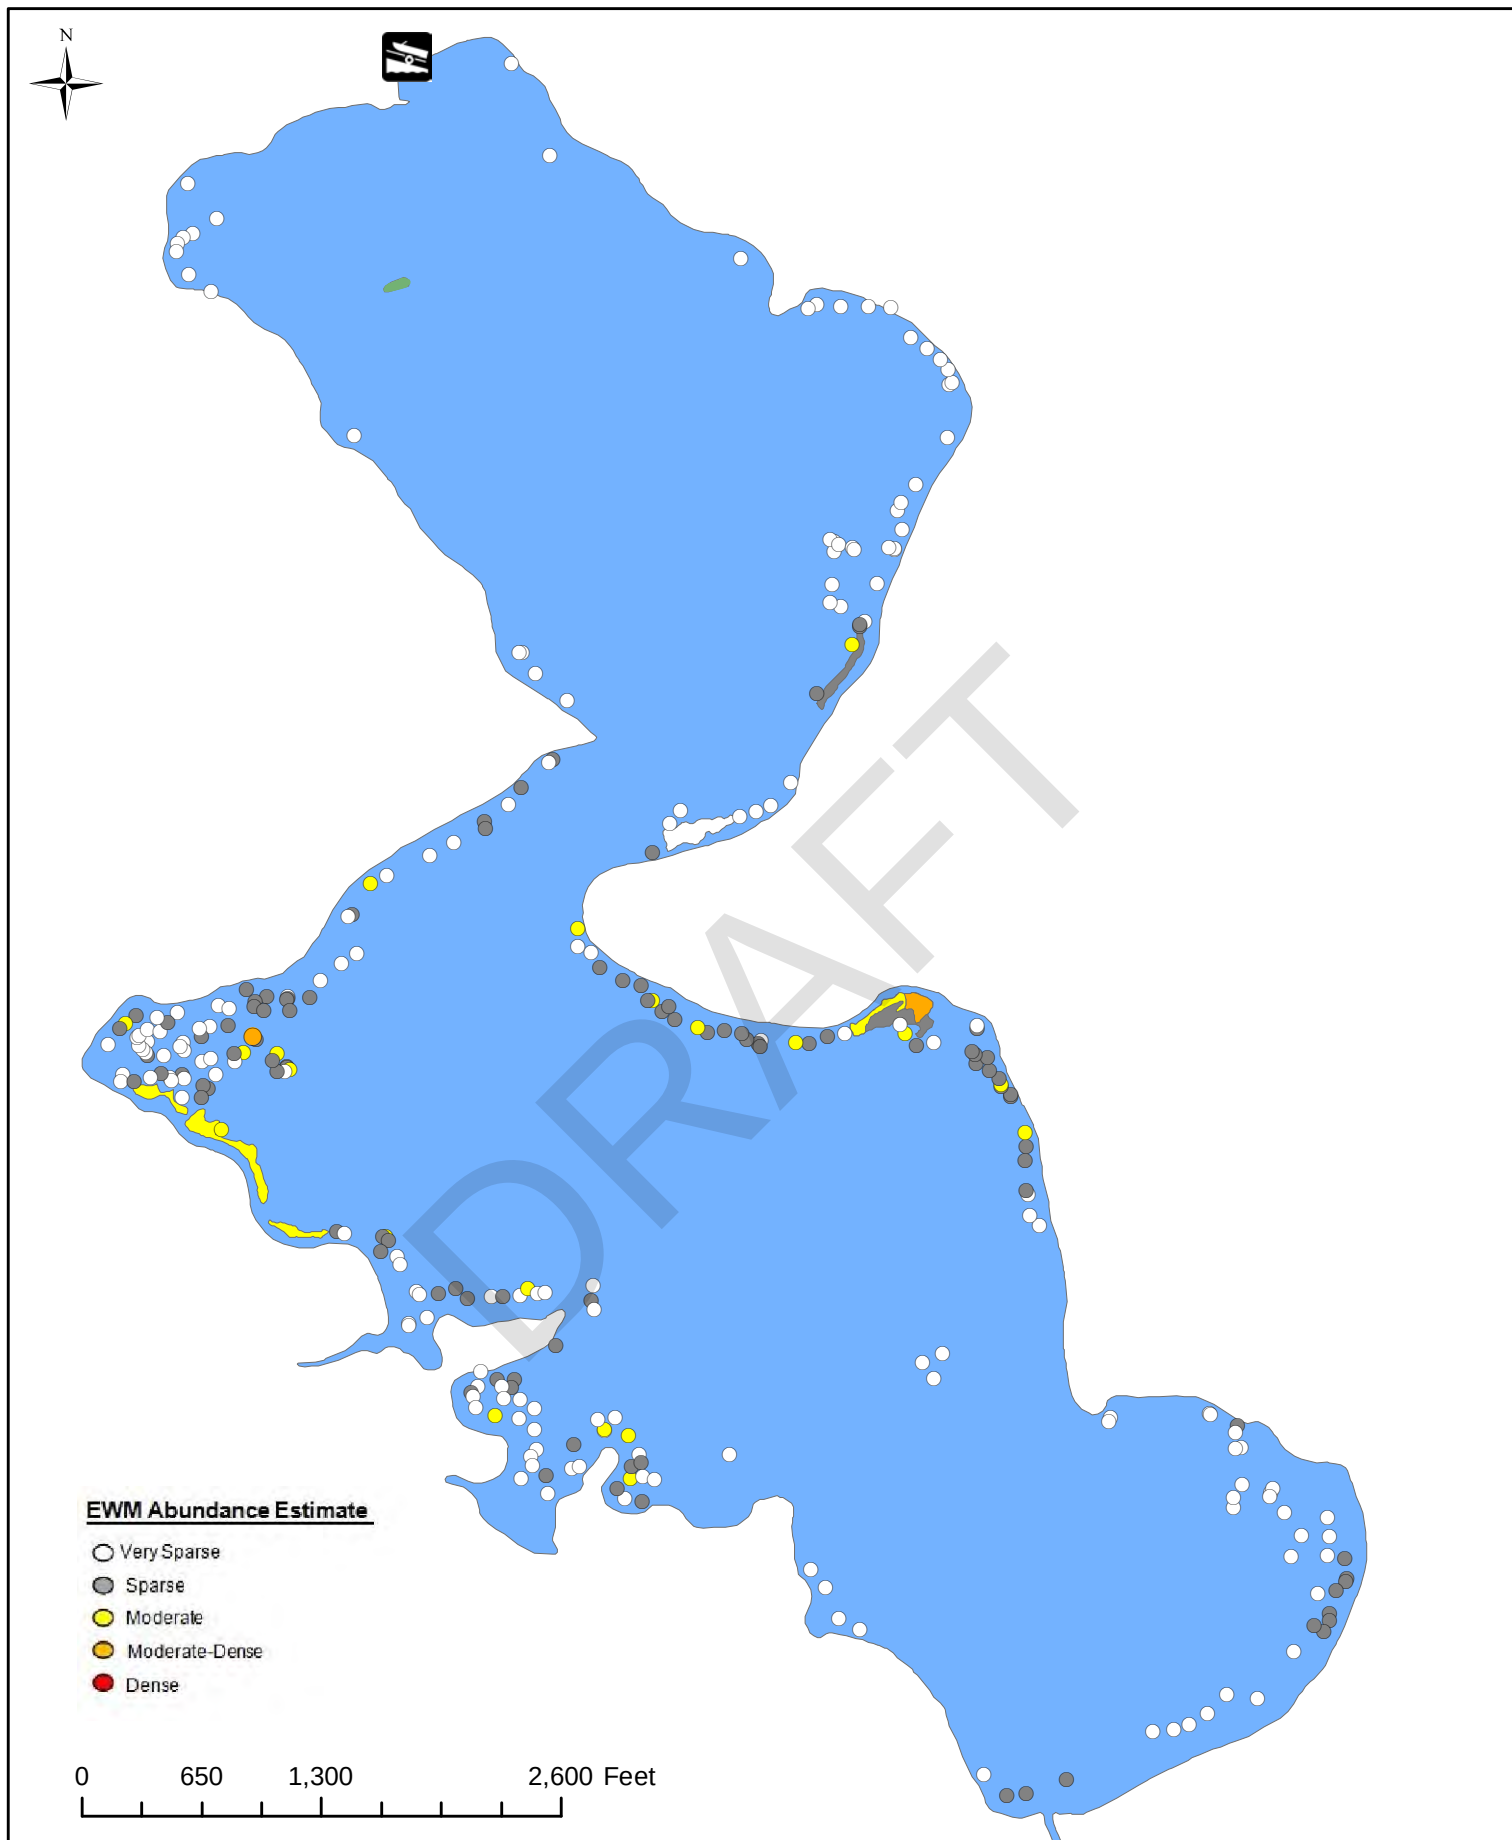
**Crescent Lake - Oneida Co, WI  
Mid/Late Season EWM Survey  
2019**

Monitoring efforts are qualitative in nature, meaning information collected describes the condition or population of the target AIS rather than relying on measured or quantitatively collected and calculated values. Smaller sites are geo-referenced with a GPS point and extent is determined by visually estimating coverage in foot-circumference. This is an observed estimate of exact extent, not footprint. On average, these sites are less than a 0.10 of an acre in size. Larger sites, typically greater than a 0.10 of an acre in size, are circumnavigated and extent in acres is calculated and represented on a map with a polygon. Mid/late season monitoring point based mapping estimated 17 acres of EWM, whereas polygon based mapping delineated 4.1 acres of EWM, for a total of 21.1 acres.
